Pit-and-Fissure Dental Sealants

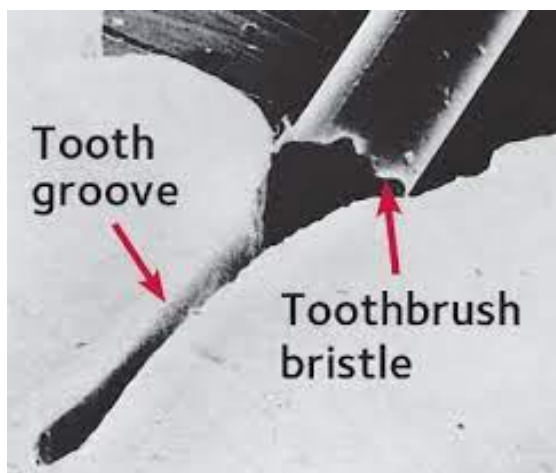
The following is of a magnified view of a groove/fissure of a permanent molar, along with a single toothbrush bristle. As you can see, the extremely narrow nature of these grooves can lead to pooled areas of food debris and bacteria that cannot be washed away using a

toothbrush. Over time, these pools of bacteria can form cavities on the biting surfaces of teeth, even in the presence of well-established oral hygiene routines at home.

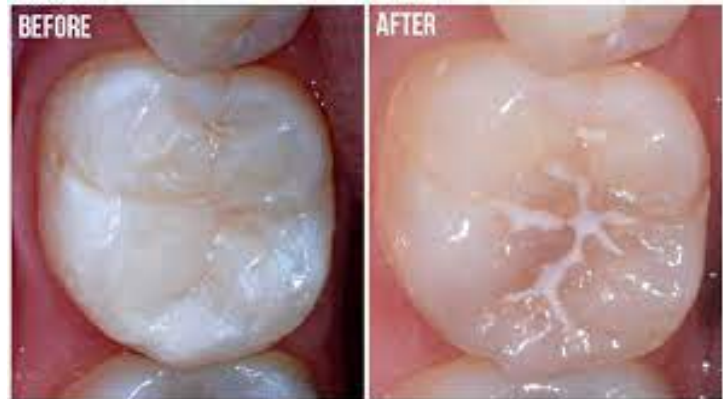
You can see how a well maintained sealant should appear in this comparison image of "Before" and "After" sealant placement. The image on the right was taken years after the original placement date of the sealant.

On occasion, heavy duty biting forces or aggressive chewing/grinding practices will chip away some of the visible portions of a sealant. We check each sealed tooth at every exam, and if we see that a sealant has chipped away, we might recommend "patching" or even at times re-sealing the tooth, to ensure we are doing all we can to prevent biting surface cavities. Research has show that even if the visible portions of the sealant have broken away, at times the deeper portions of sealant material are retained and continue to offer protective benefit.
